HISTORIC STRUCTURE REPORT

Architectural Data Section

LINDENWALD

MARTIN VAN BUREN NATIONAL HISTORIC SITE

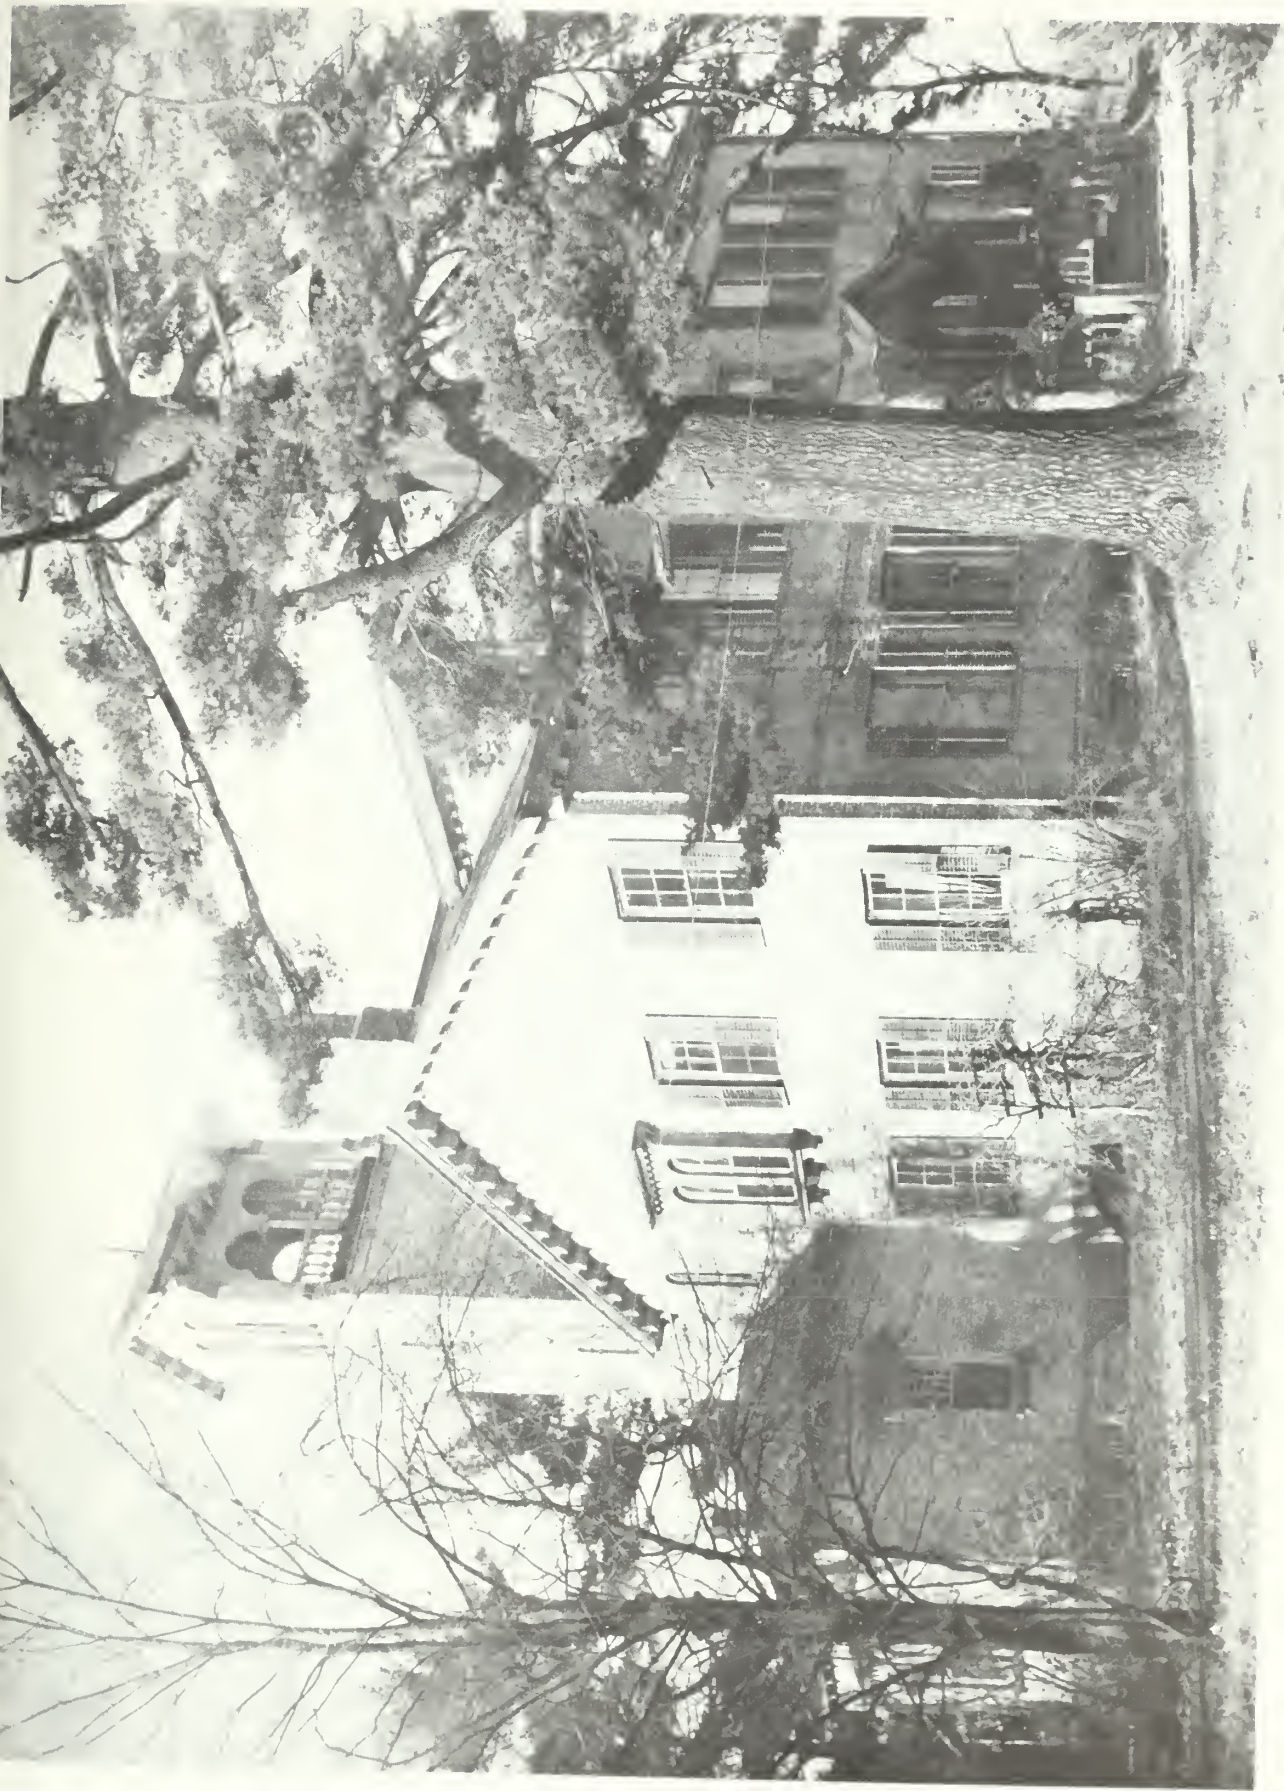
HP34. Lindenwald, East Elevation, 1937. This photograph was taken by Nelson Baldwin in January 1937. The following details should be noted:

The main cornice crown molding is deteriorating at the joints.

There is a plumbing vent stack near the ridge at the north end of the east slope.

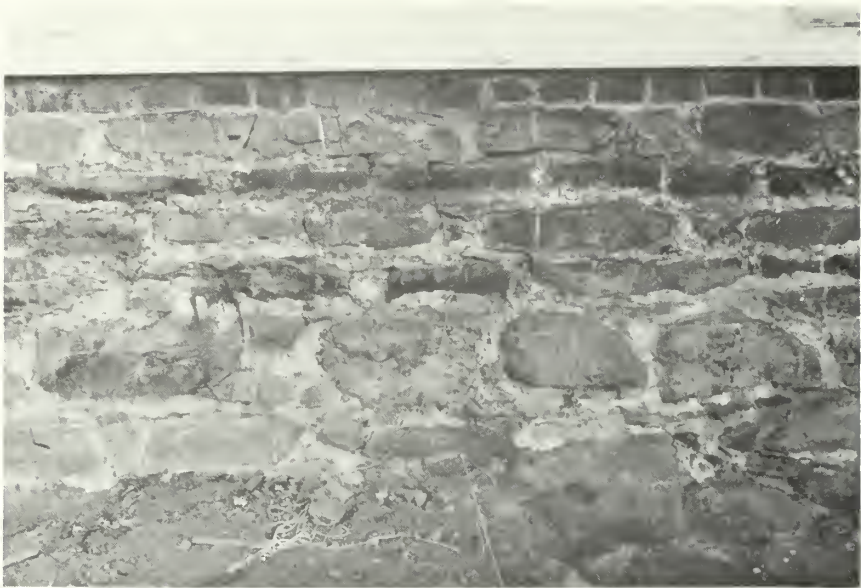
IP001, N002-04. Ca. 1797 foundation below door 101.

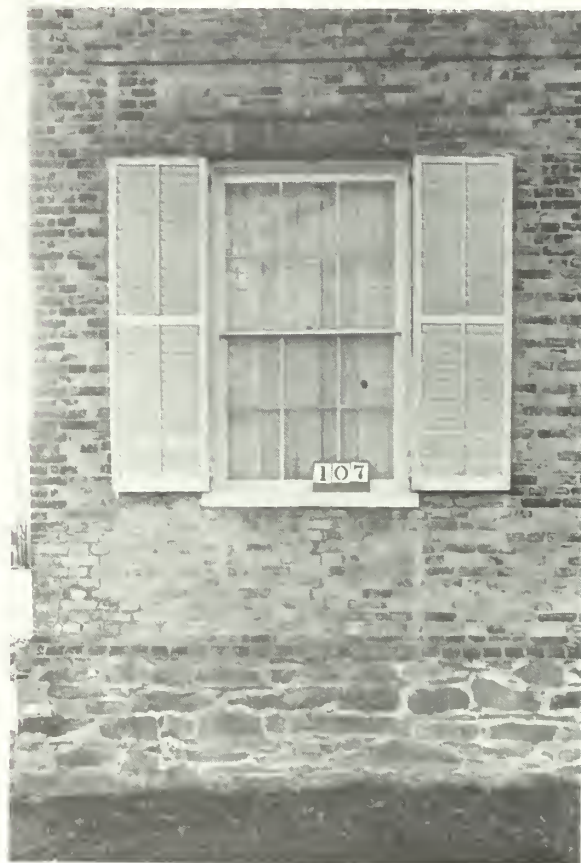
IP002, N012-14. Closure pattern at east corner of north wall.

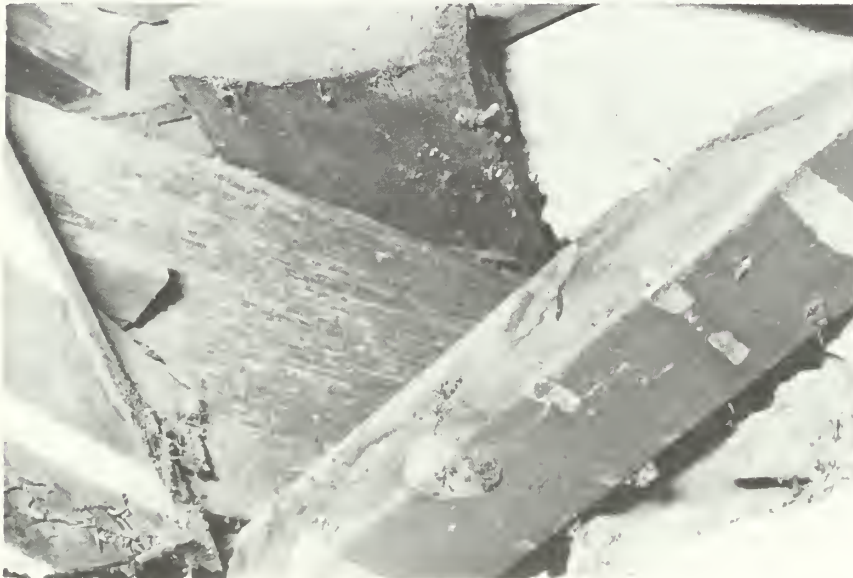
IP073, N041-12. Typical condition of cantilever joist wedged into masonry pocket.

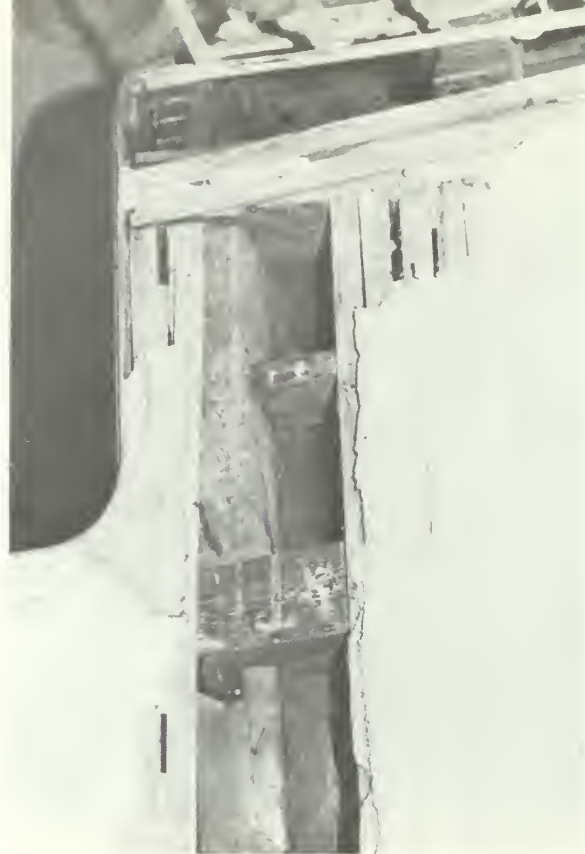
IP074, N041-05. Tower stair construction at a landing, looking up and slightly south. Note that joist running across photograph is continuous between two brick walls of tower. Stub joist to support stair stringer is vertical member mortised through main joist and pulled tight by wedge.
